Manhole Inspection Summary

Manhole # S41Y1_022MH

Insp Date: **5/6/08 12:21 PM**

Location Address: **3544 7th Street**

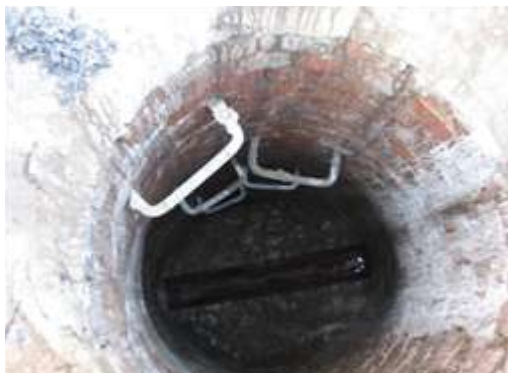
Steps Count: **5** Missing: **0** ☒ **Corroded**

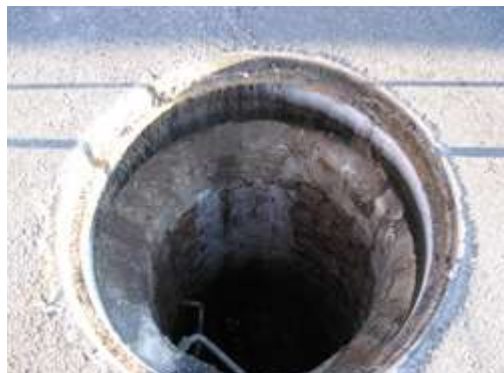
Defect 1

Infiltration: ☐ None ☒ **Joint** ☐ Cracks ☐ Mortar ☐ Roots ☐ Wall

Joint

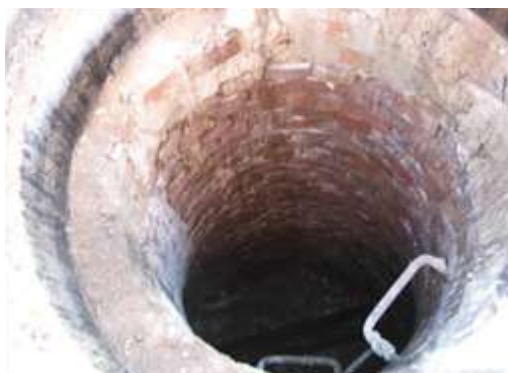
Defect 2

Infiltration: ☐ None ☐ Joint ☐ Cracks ☐ Mortar ☐ Roots ☒ **Wall**

Wall

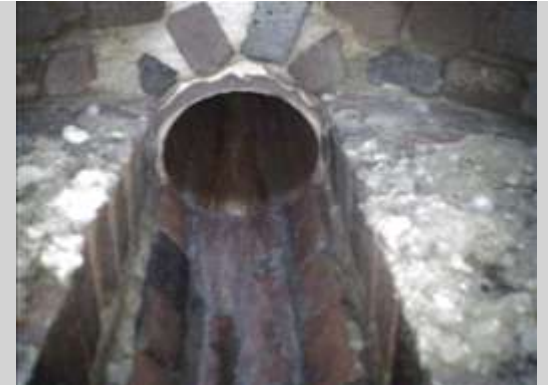
12 O'Clock Outflow

8 in. Circular Gravity Sewer
Pipe Out @ 12 O'Clock

Pipe Height: **9.6** (in.) Rod and Bar (Angled)
Pipe Material: **Clay** ☐ Pipe Lined
Invert Depth: **10.56** (ft.) Flow Characteristics: **Fast**
Deposits: ☒ None ☐ Mud ☐ Sludge ☐ Debris ☐ Grease
Silt Depth: (in.) Deposits Extent:
Infiltration: **None** Pipe Seal Cond: **Sound**

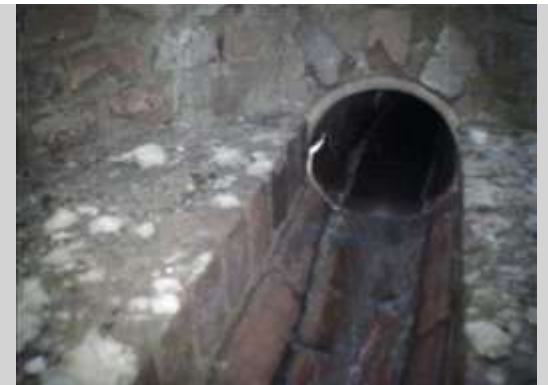
6 O'Clock Inflow

8 in. Circular Gravity Sewer
Pipe In @ 6 O'Clock

Pipe Height: **9.6** (in.) Rod and Bar (Angled)
Pipe Material: **Clay** ☐ Pipe Lined
Invert Depth: **9.94** (ft.) Flow Characteristics: **Fast**
Deposits: ☒ None ☐ Mud ☐ Sludge ☐ Debris ☐ Grease
Silt Depth: (in.) Deposits Extent:
Infiltration: **None** Pipe Seal Cond: **Sound**
